# Conservation Report

## Gray Scale / Photographs / Damage Evidence

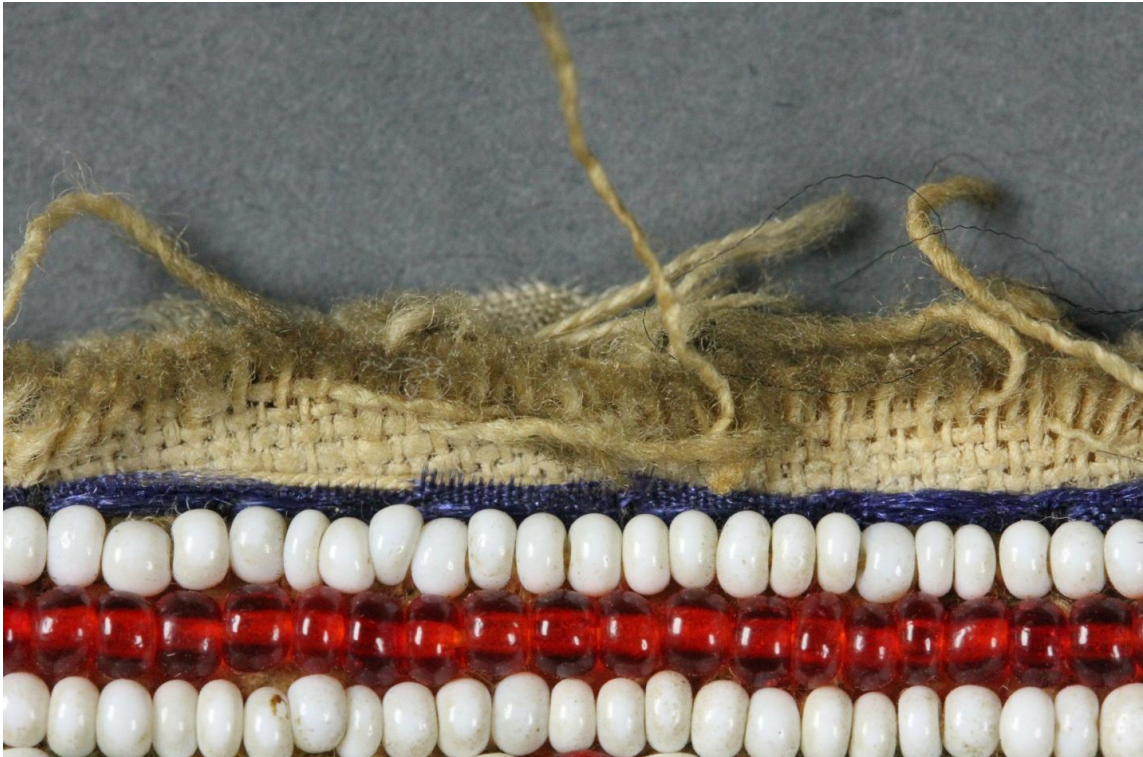
Fig. 1 – Frayed Edging – Lower front center

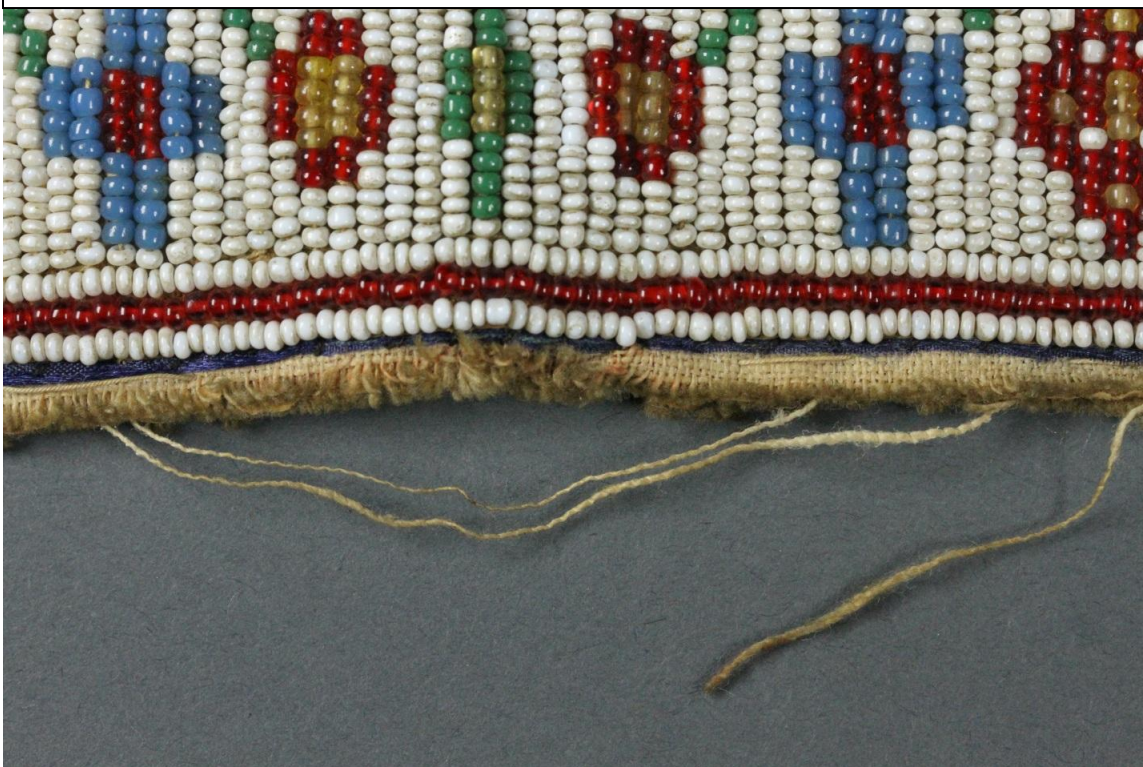
Fig. 2 – Loose Threads – Lower front center

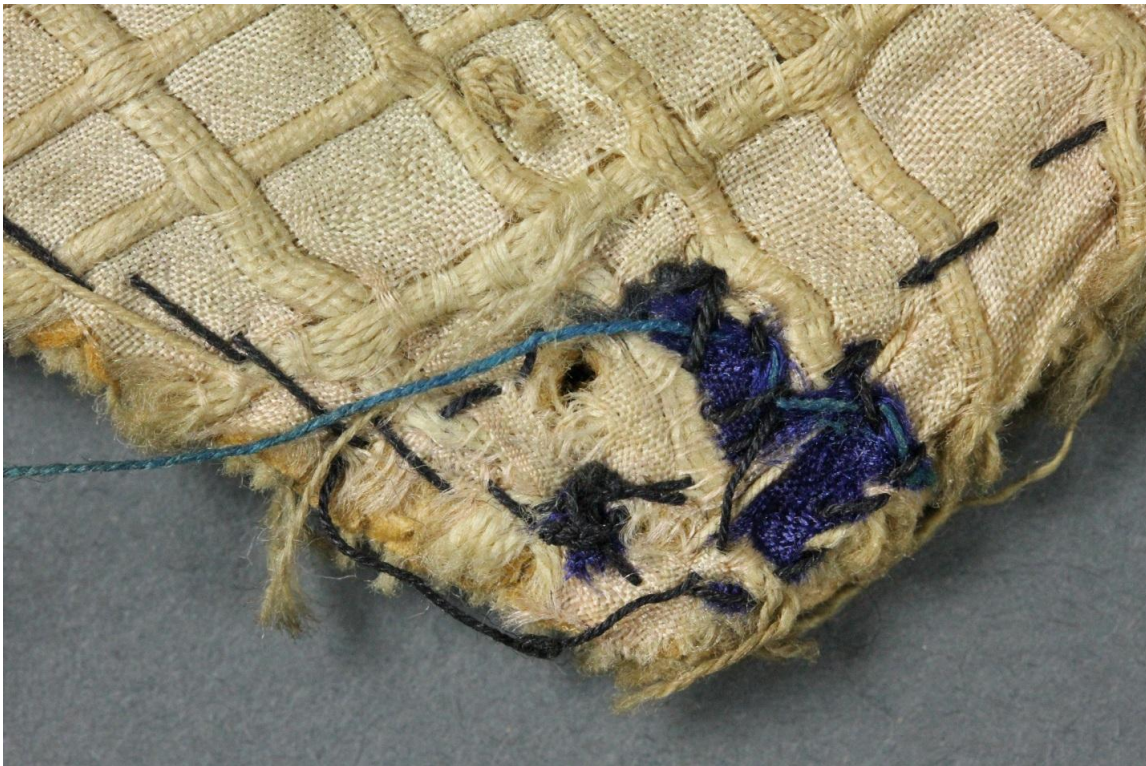
Fig. 3 – Missing Trim Textile – Back Top right corner edge

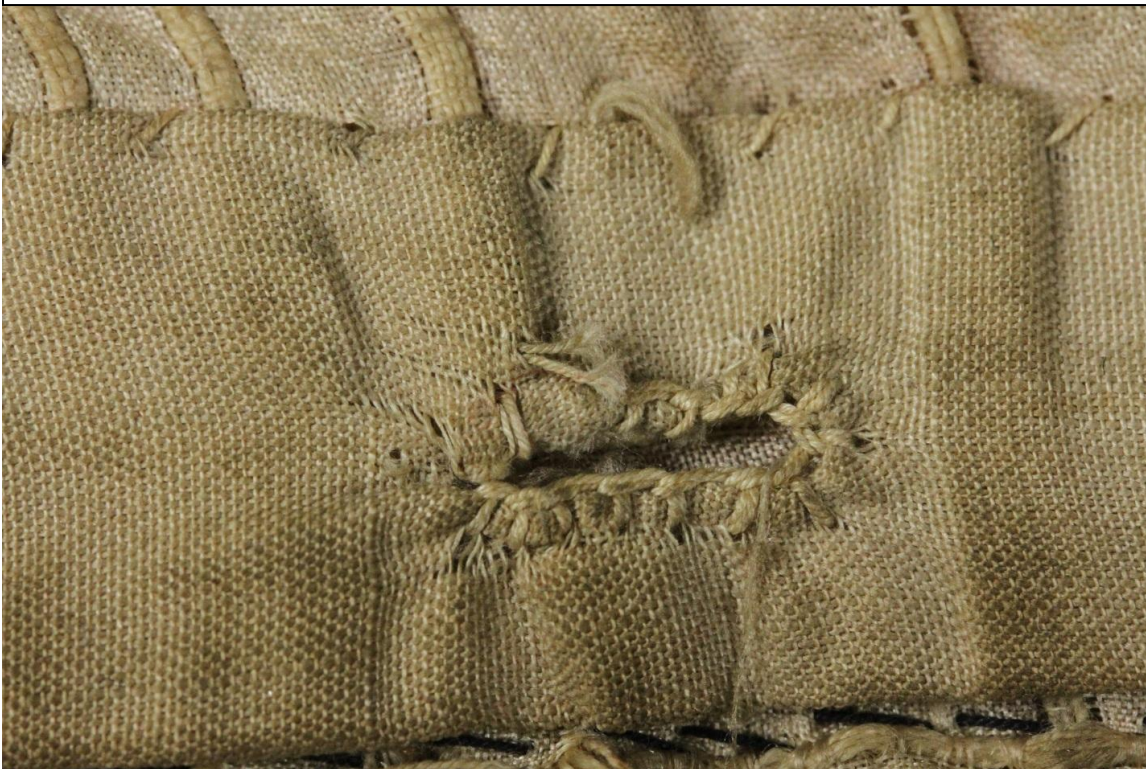
Fig. 4 – Loose textile – Back center

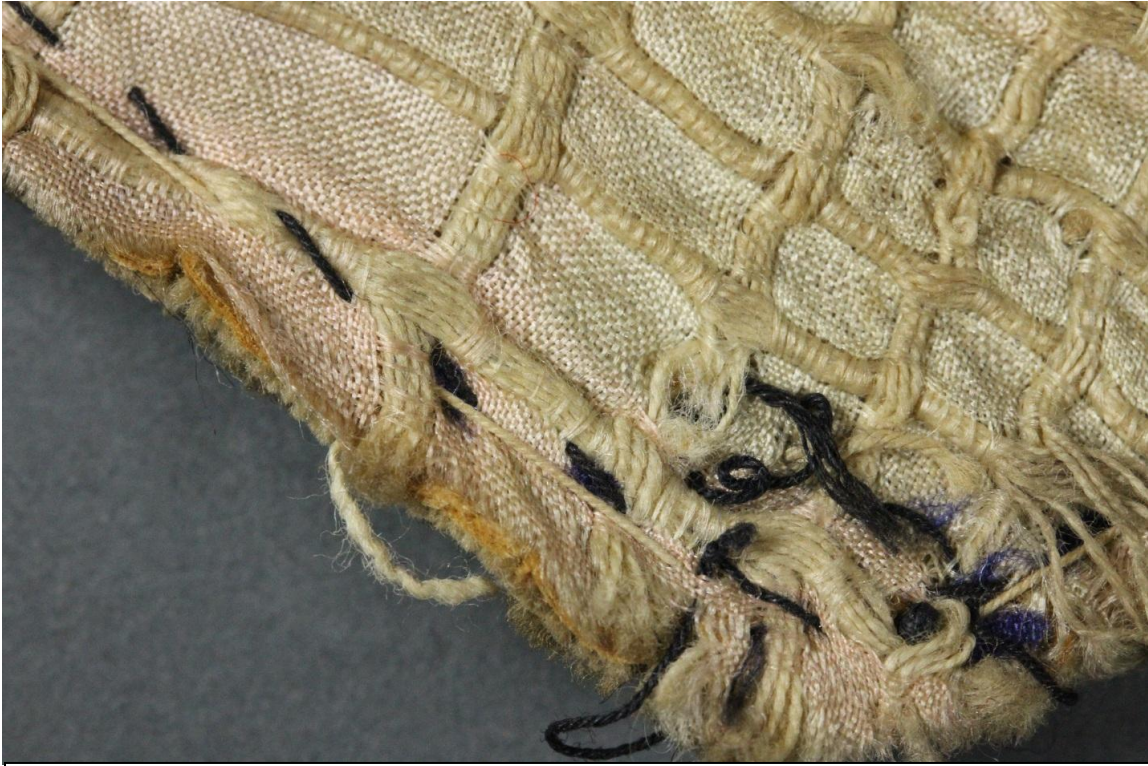
Fig. 5 – Repair stitching – Top back left corner
